The anti-skimming kit is a security device installed in ATMs.

We were informed that a large number of ATMs presented false alarm events after updating the sensors for the G2 version.

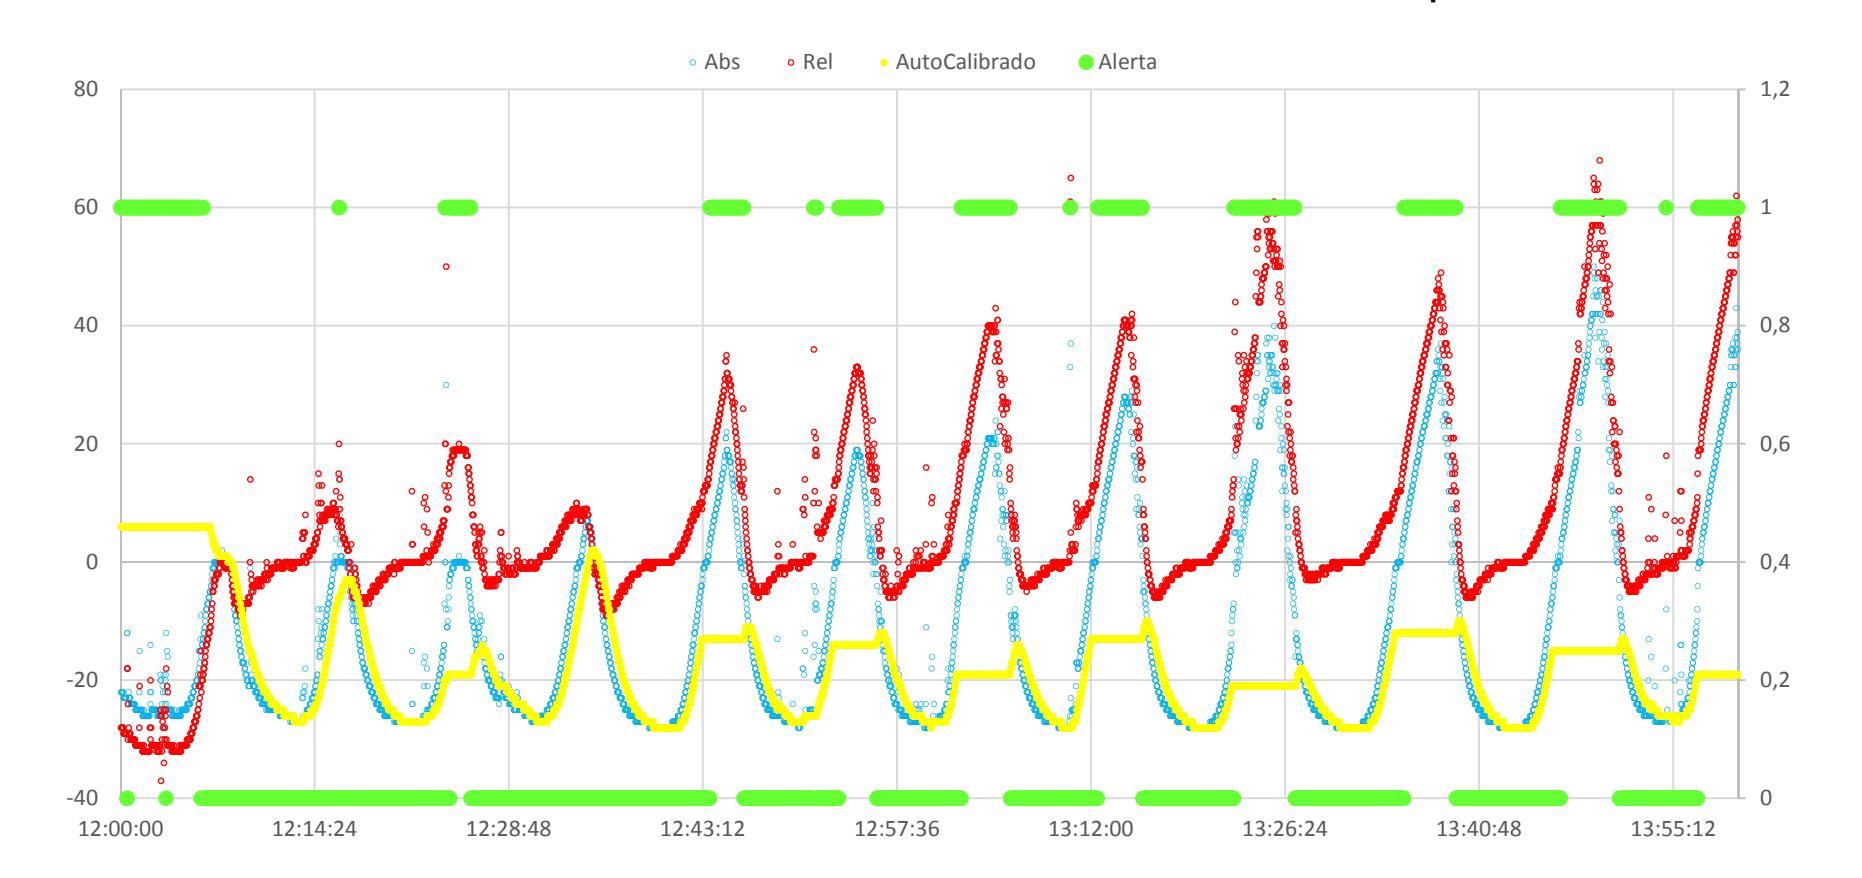
This analysis was initially carried out at the ATM Tesai CDE, on the 25/09. This cashier had many daily activations, achieving a maximum stability period of 1 hour.

The graph below illustrates the behavior of the sensor over a period of two hours.

Under ideal conditions, the yellow line (AutoCalibration) should always be close to the blue line (Absolute Value of the sensor). The red line (Activation Value), is the difference between these two values. The sensor is activated whenever the Activation Value reaches 18 points.

In this analysis, it was found that the variation of the blue line was very fast (many variation points in a few seconds), moving away from AutoCalibration (yellow line).

The standard AutoCalibrate speed was not sufficient to maintain the Absolute Value of the sensor and the AutoCalibrate value equal.

Based on the information of this cashier, a change in the sensor parameters was made, so that the AutoCalibrado is faster.

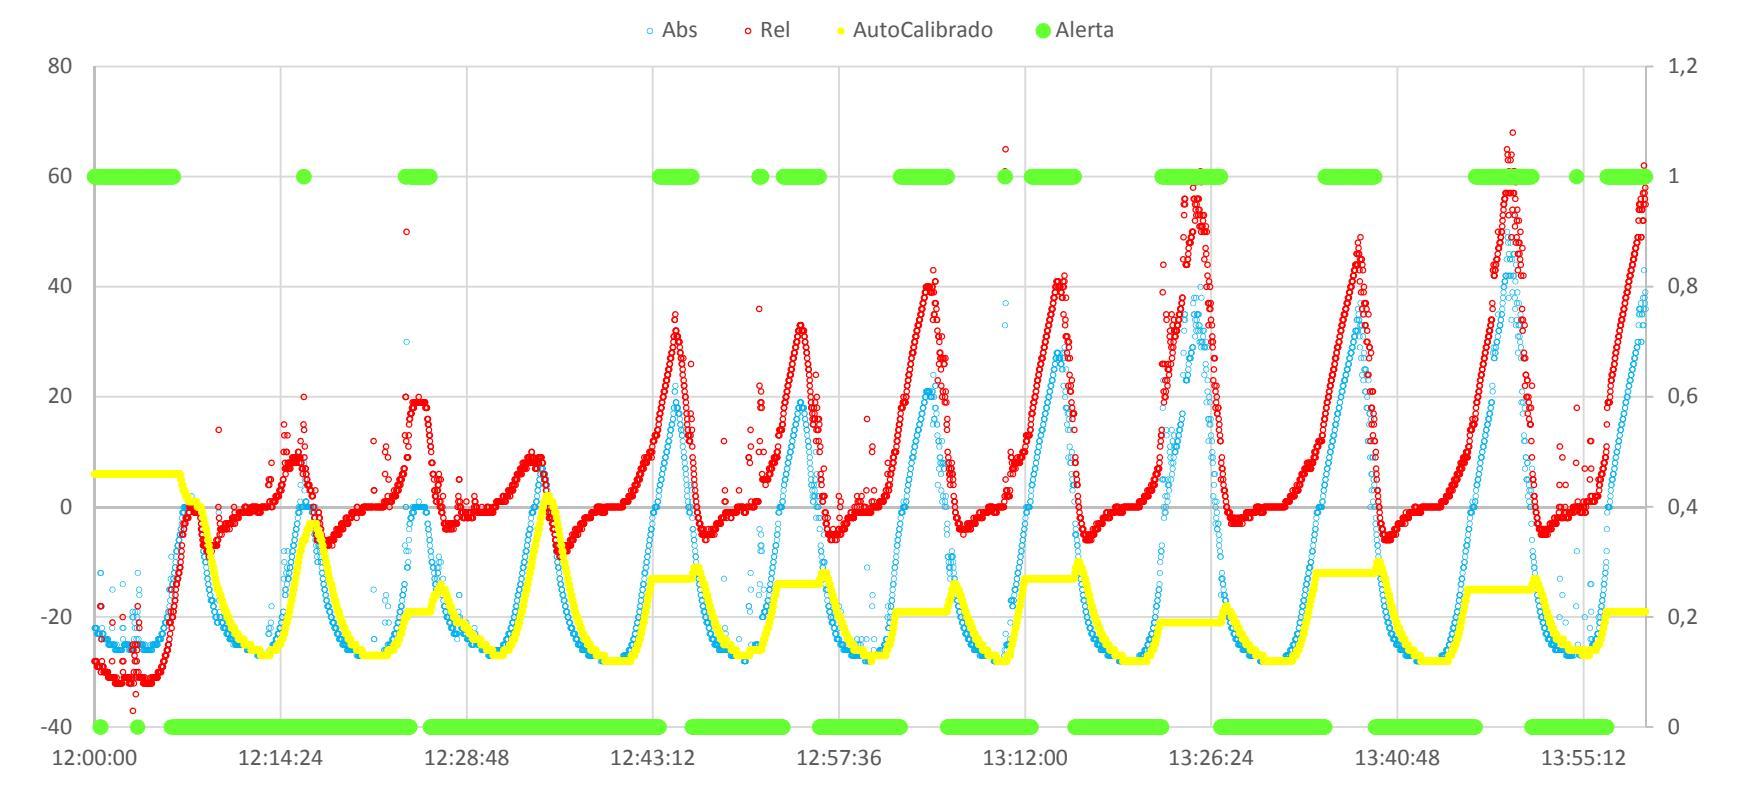
This ATM, which previously had a maximum stability period of 1 hour, remained 24 hours running, until the first false alarm event.

On 01/10 and 02/10, this version was implemented with parameter changes (FW1.1) in 6 ATMs, including the CDE ATM.

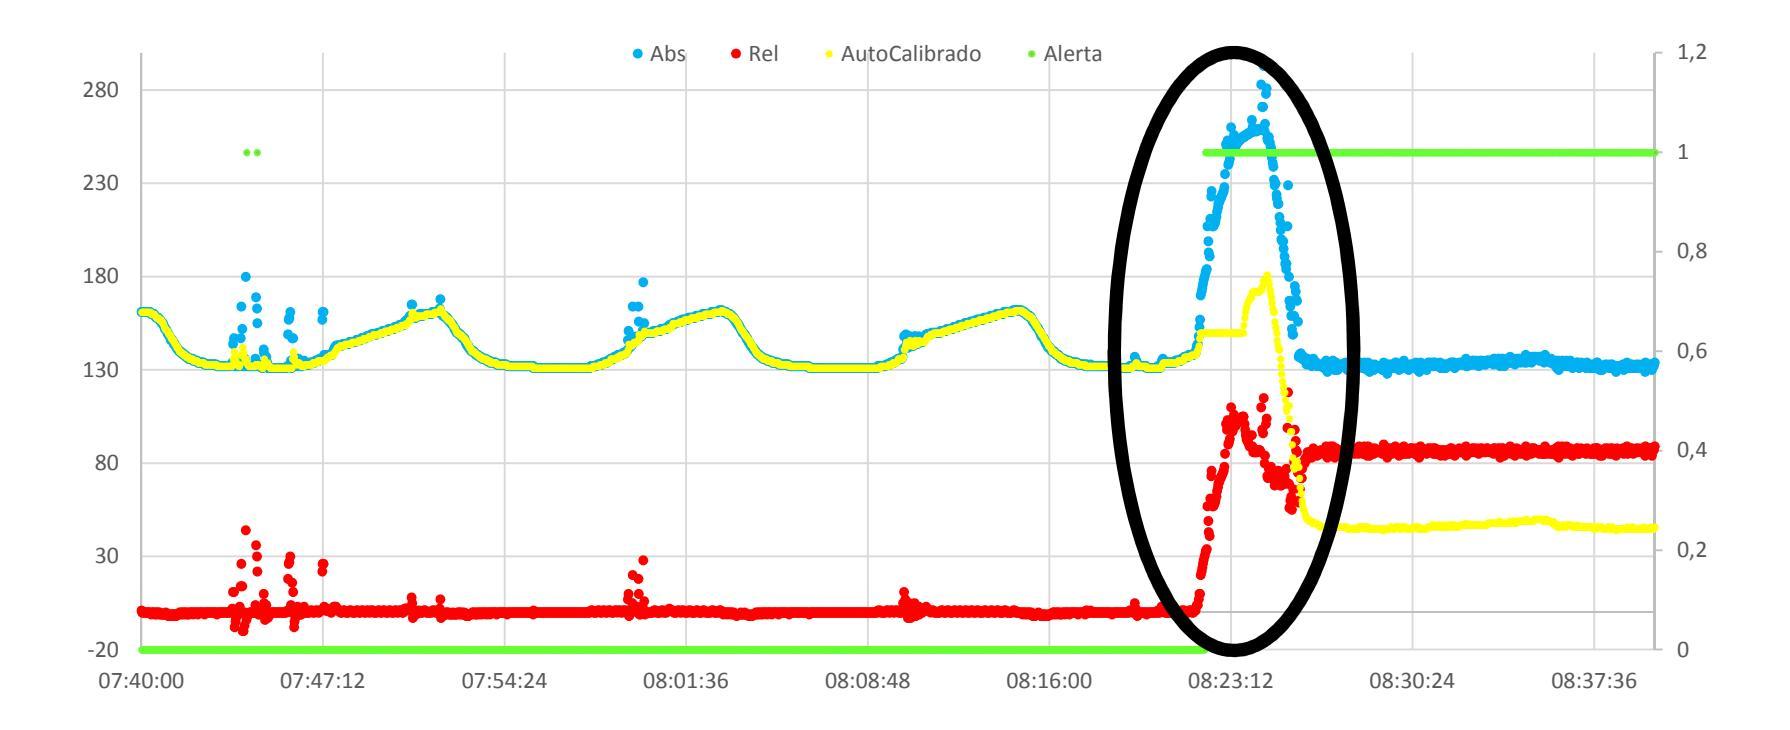
Analyzing this new event on 03/10, we found a new great variation (highlighted in the graph below).

Based on this, a second version (FW1.2) was generated, with a faster AutoCalibrate speed, higher AutoCalibrate operating range and higher sampling rate.

This version of FW1.2 was updated in the equipment in warehouse and will be implemented in production ATMs on 08/10 and 09/10.

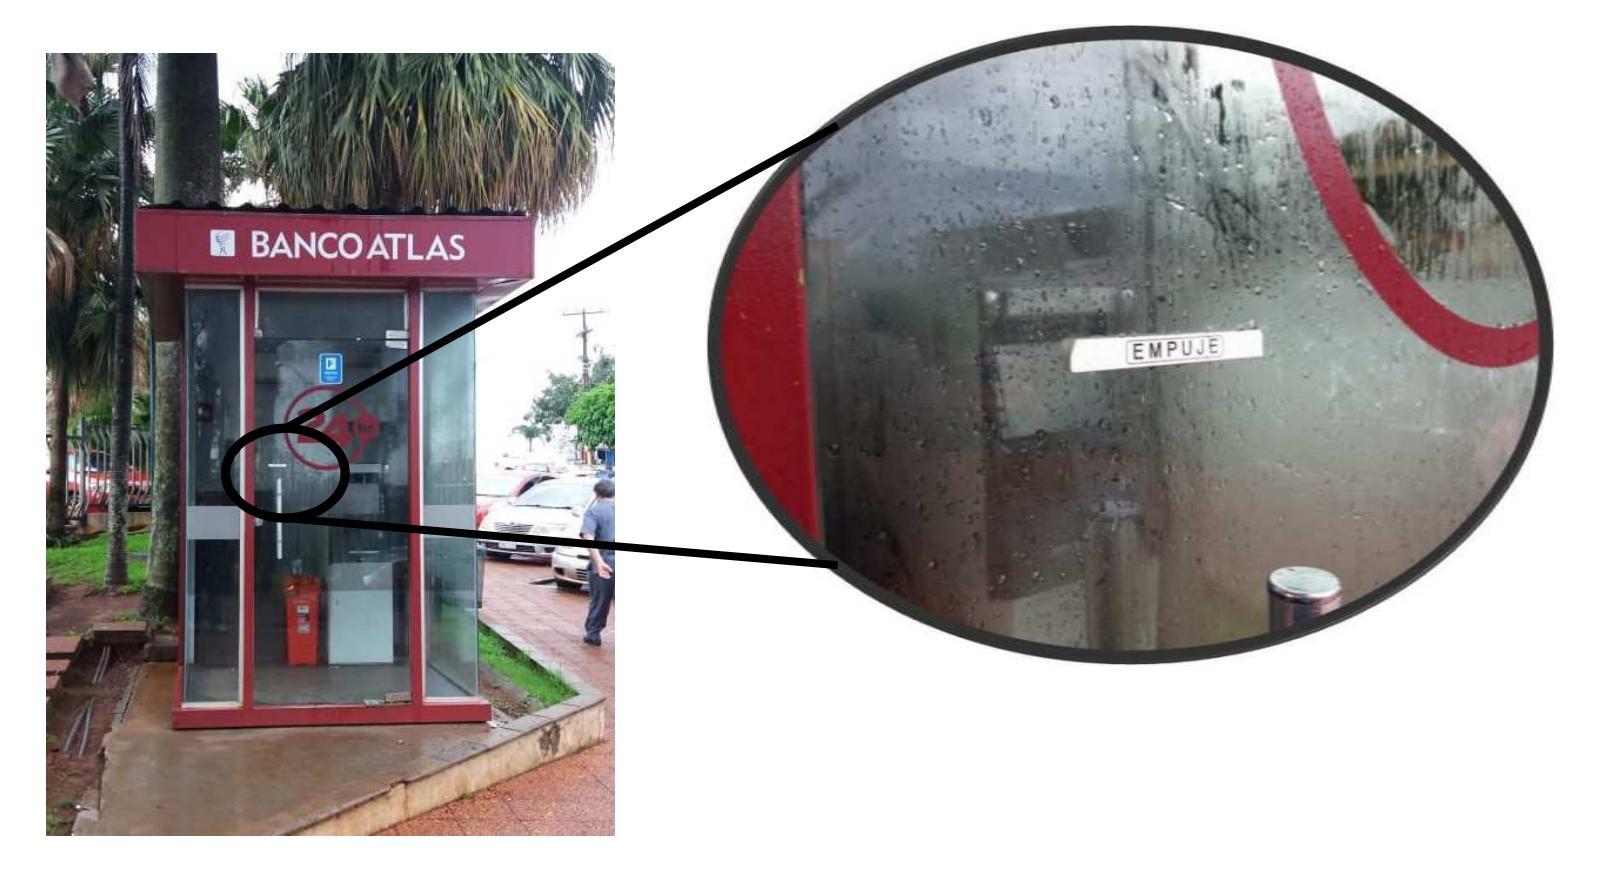
Evaluating the ATM environment, we find that all ATMs are in airconditioned environments with air conditioning. But around the cashier, it is subject to weathering.

The photo below shows water condensation on the surface of the cashier's room.

This means that the interior is cold and the exterior very humid.

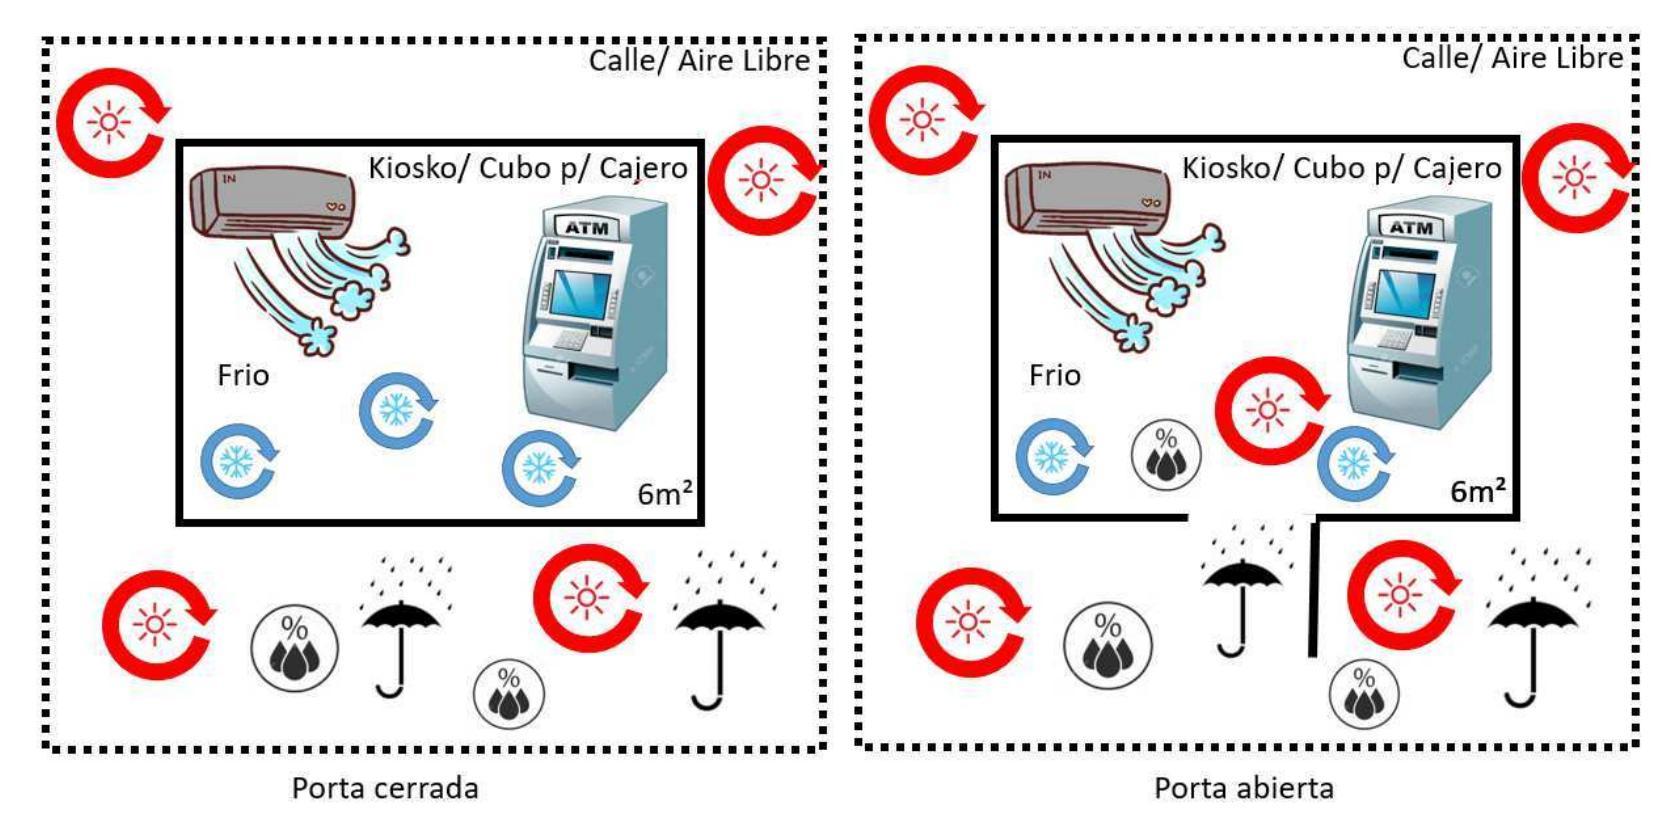
The figure below details the conditions that generate variations in sensor behavior.

Under normal conditions, with the cashier's room closed, the sensor environment is cold and dry, due to the conditioned air. When opening the door, a hello of heat / humidity, advances on the cashier, causing that there is a large and rapid variation in the environment monitored by the sensor.
